# Analysis of the Line of Duty Death of Firefighter Nathan Flynn Utilizing Fire Dynamics Simulator, Fire Testing and Electronic Data Sources

7005 Woodscape Drive, Howard County, MD

Incident Date: July 23, 2018

**ATF BALTIMORE FIELD DIVISION**

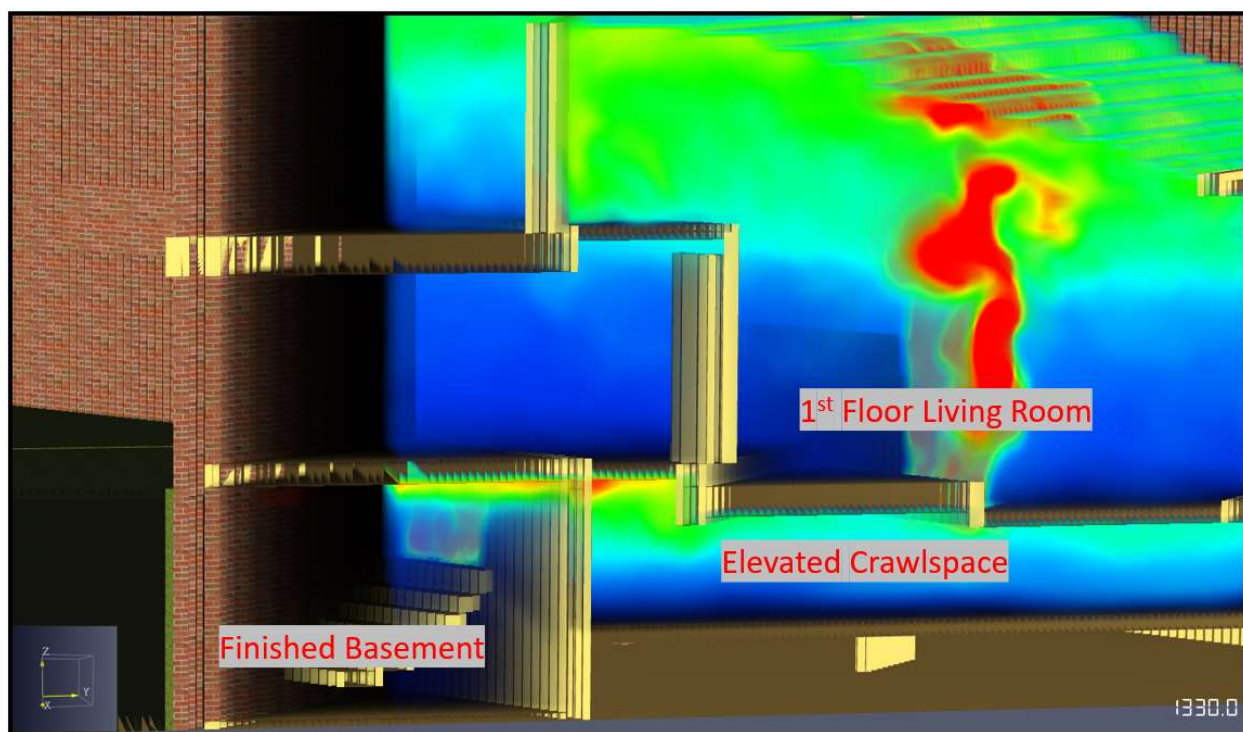
**Figure 45. Pyrosim Results image (sectional view) depicting smoke filling and relative temperature during the MAYDAY and RIT rescue operation. Flames intensified as the size of the hole increased and additional air was introduced through the basement door. The stairs leading up to the crawl space entrance can be seen on the left side of the image.**

The hole acted like a chimney and a unidirectional flow of hot exhaust gases flowed through the hole and out of the mudroom door. The free-burning crawl space and the fire gases venting up through the hole created untenable conditions for firefighters on the first floor to attempt a rescue from above. The RIT crew and rescue operations were directed from the basement level at-grade entrance on lower side C.

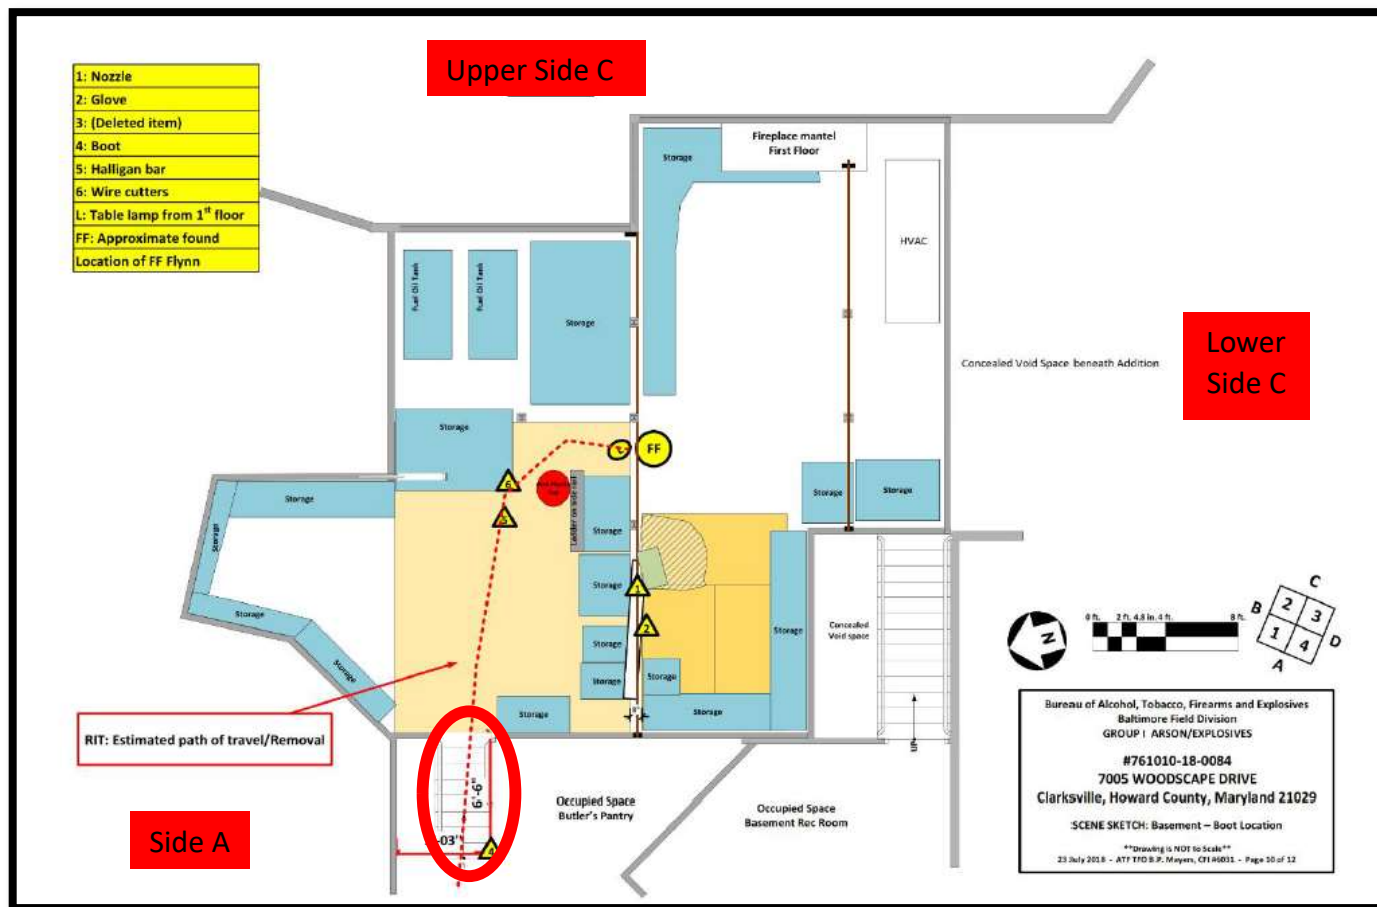
Figure 46. Crawl space diagram depicting the ½ flight of stairs leading from the basement to the small crawl space entrance. No door was present at the entrance to the crawl space. The red dotted line indicates the path taken by RIT crew members to locate and extricate Firefighter Flynn. Firefighter Flynn's location is depicted by a yellow circle.

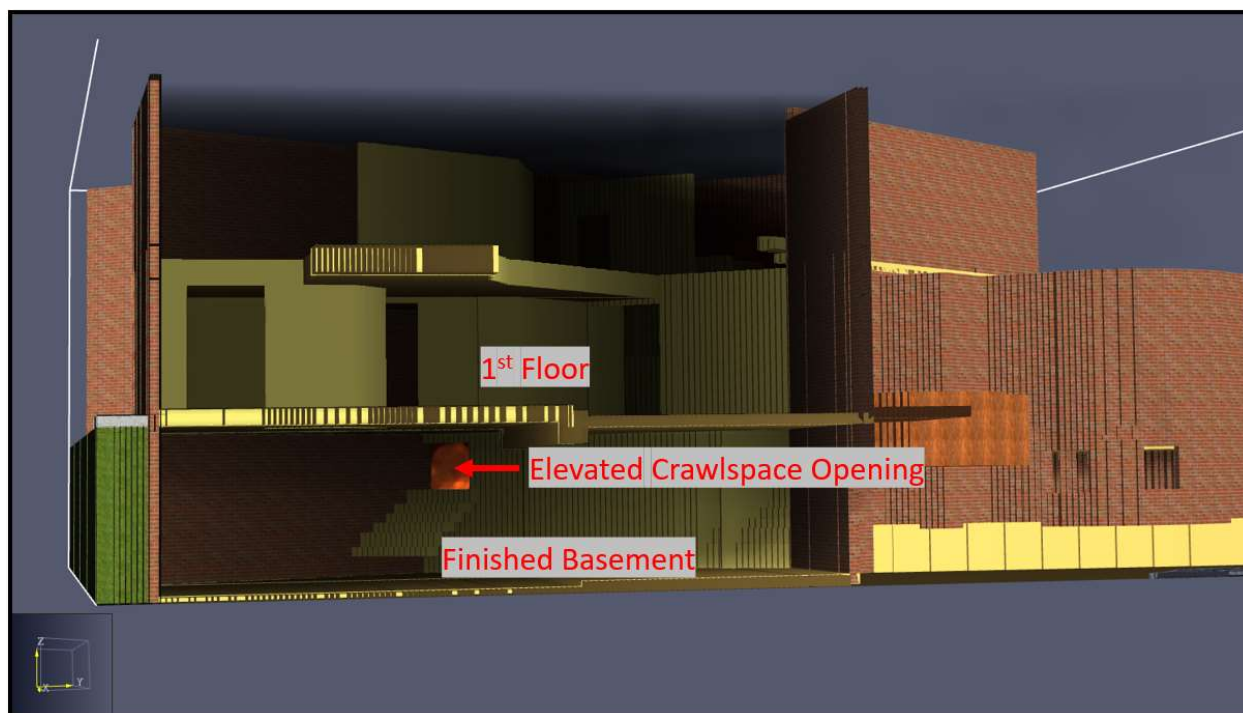
**Figure 48. Pyrosim Results image (sectional view) depicting fire conditions at the crawl space entrance during the MAYDAY/RIT operation. Crews encountered “cold smoke” in the basement and flames throughout the crawl space.**

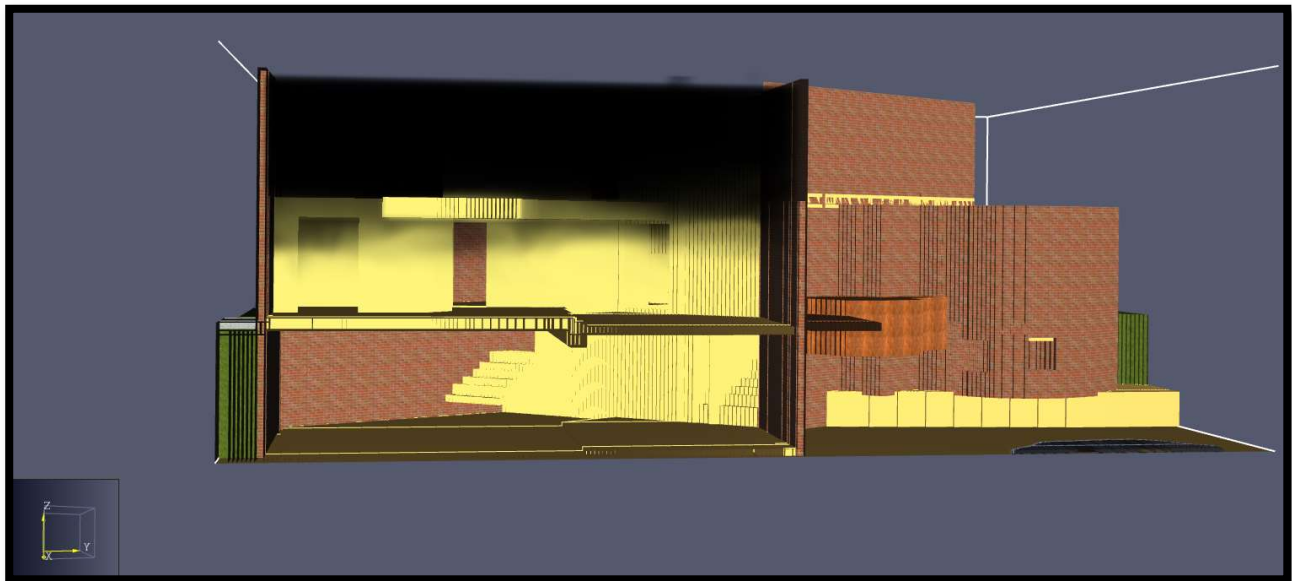
**Figure 52. Pyrosim Results image indicating smoke filling and ventilation limited conditions reached after 280 seconds of fire growth. The fire was placed on the 2<sup>nd</sup> (top) floor, allowing the fire to grow for 280 seconds until the smoke layer dropped below the level of the flames, thus limiting fire growth.**

Firefighters can use the height of the smoke layer to assist them in locating the level of the fire. It is often safest to attack the fire from the same level of the flames, or the level below, where possible. In addition, personnel may also consider the level of the fire/smoke filling of the structure when determining how much oxygen may have been available to a fire prior to arrival. Fires located on the top floor of a residence often become ventilation limited much sooner (and are easier to locate/suppress) as compared to the same fire located in the basement, as the smoke layer takes longer to descend to the level of the flames. Again, firefighters should consider ensuring that the basement is completely free of smoke and fire, including at the basement ceiling level where CSST may be routed, as part of fire scene size-up operations.

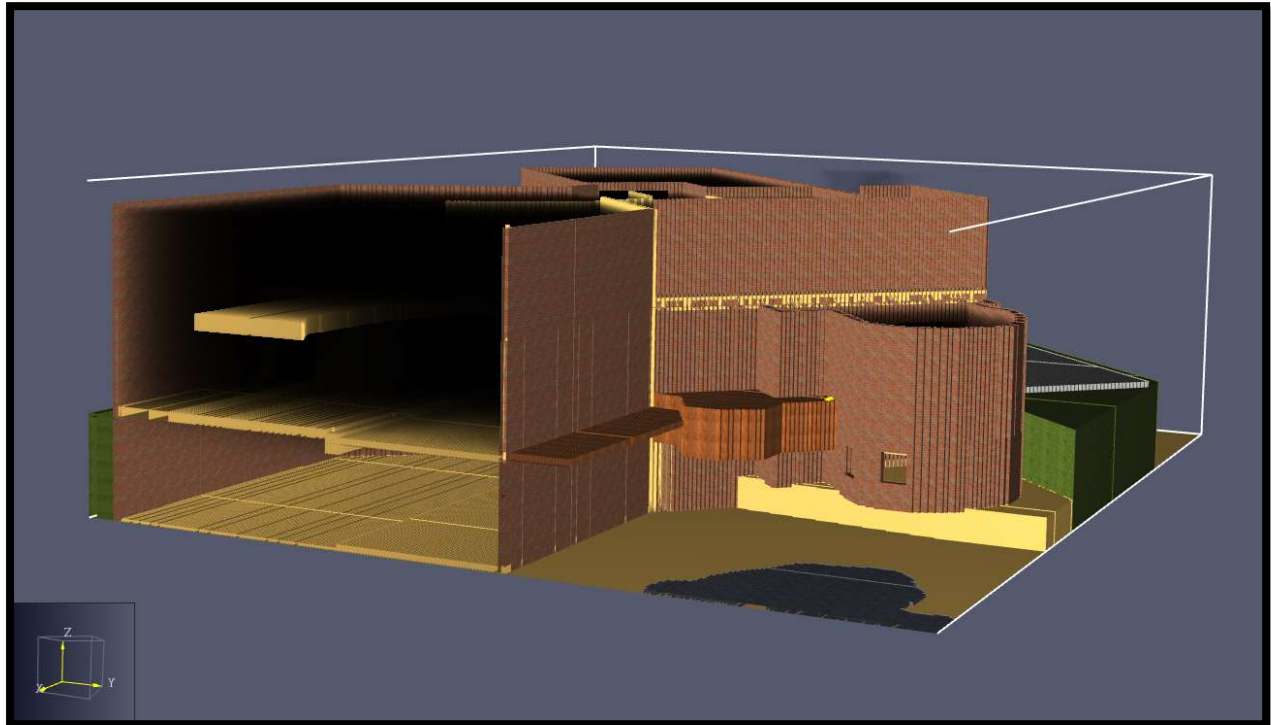
**Figure 53. Pyrosim Results image indicating smoke filling and ventilation limited conditions reached after 385 seconds of fire growth. The fire was placed on the 1<sup>st</sup> (middle) floor, allowing the fire to grow for 385 seconds until the smoke layer dropped below the level of the flames, thus limiting fire growth.**

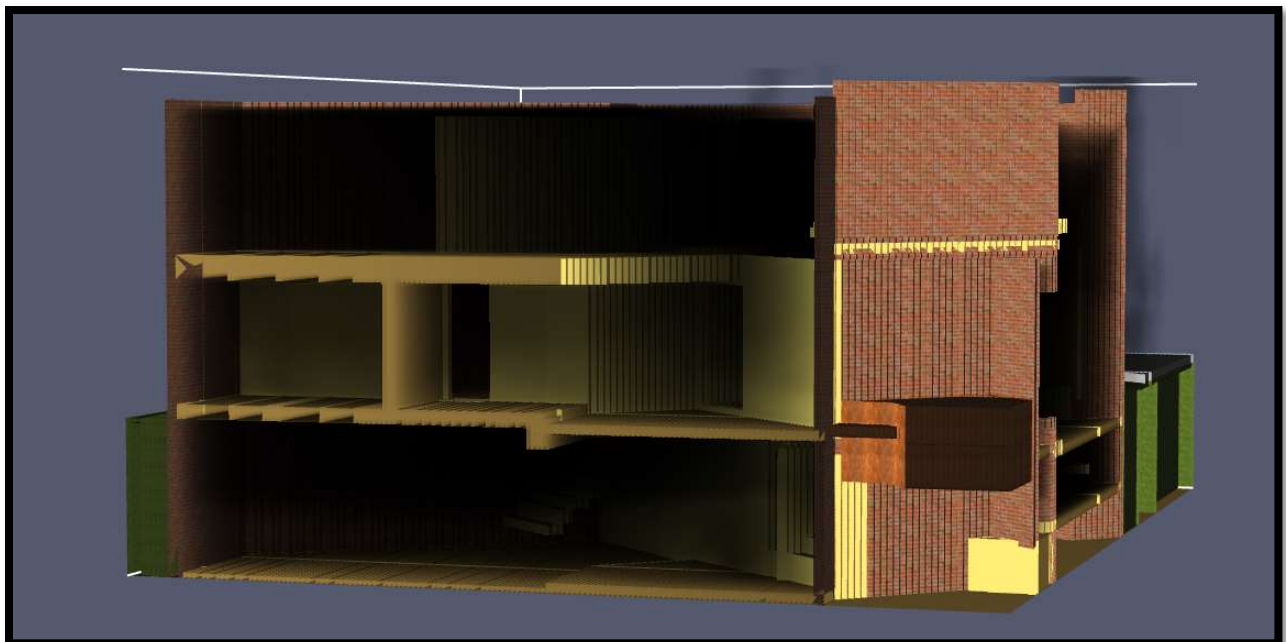
**Figure 54. Pyrosim Results image indicating smoke filling and ventilation limited conditions reached after 820 seconds of fire growth. The fire was placed in the basement, allowing the fire to grow for 820 seconds until the smoke layer dropped below the level of the flames, thus limiting fire growth.**

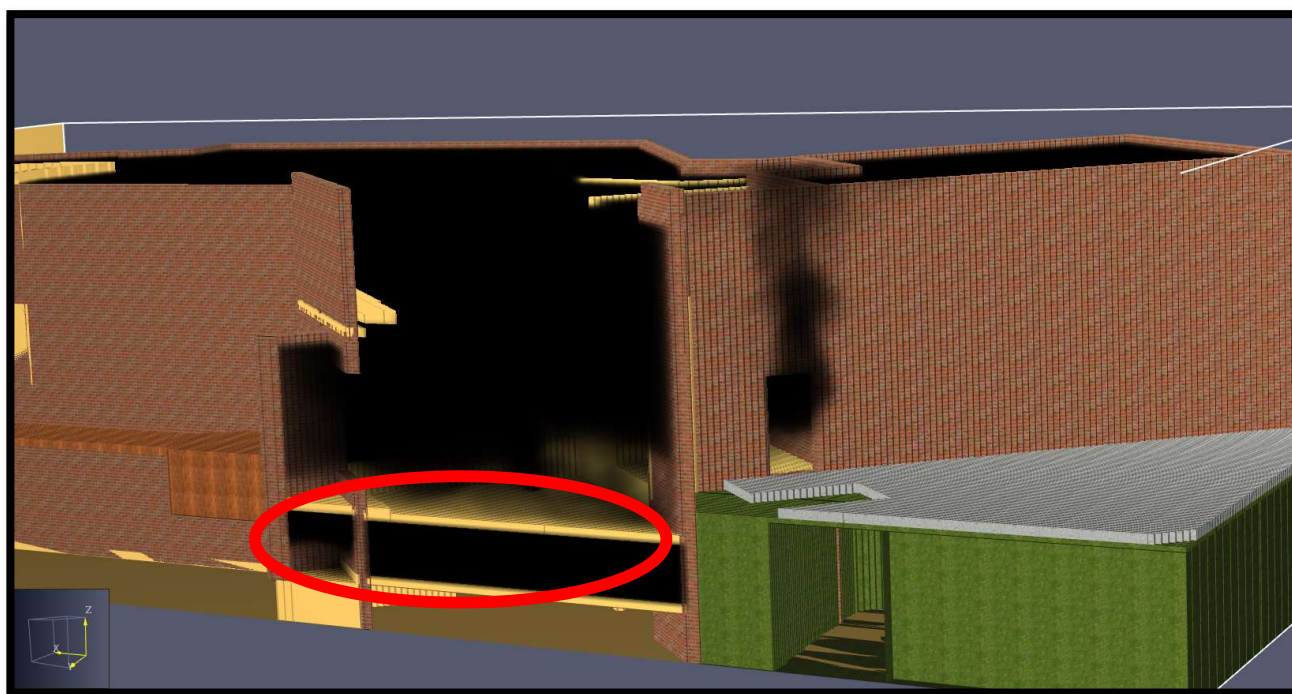
The crawl space was located at an intermediate height, approximately 1.5 meters (5 feet) above basement floor and below the level of the first floor. When crews initially entered the first floor, they identified heat and smoke signatures consistent with a basement fire below them. Upon repositioning to the basement level, the same crews identified smoke filling consistent with a fire above the basement level due to relatively elevated “cold smoke” and minimal heat in the basement. The crew then withdrew from the basement once flames were seen in the first floor living room from the exterior. The fire conditions observed were inconsistent with a fire in the basement and also inconsistent with a fire on the first level. In reality, the crews correctly identified an elevated fire (in the elevated crawl space) that was in fact below the first floor and also above the basement level.

**Figure 49. Pyrosim Results image (sectional view) depicting the height of the crawl space relative to the first floor mud room entrance. The crawl space is circled in red.**

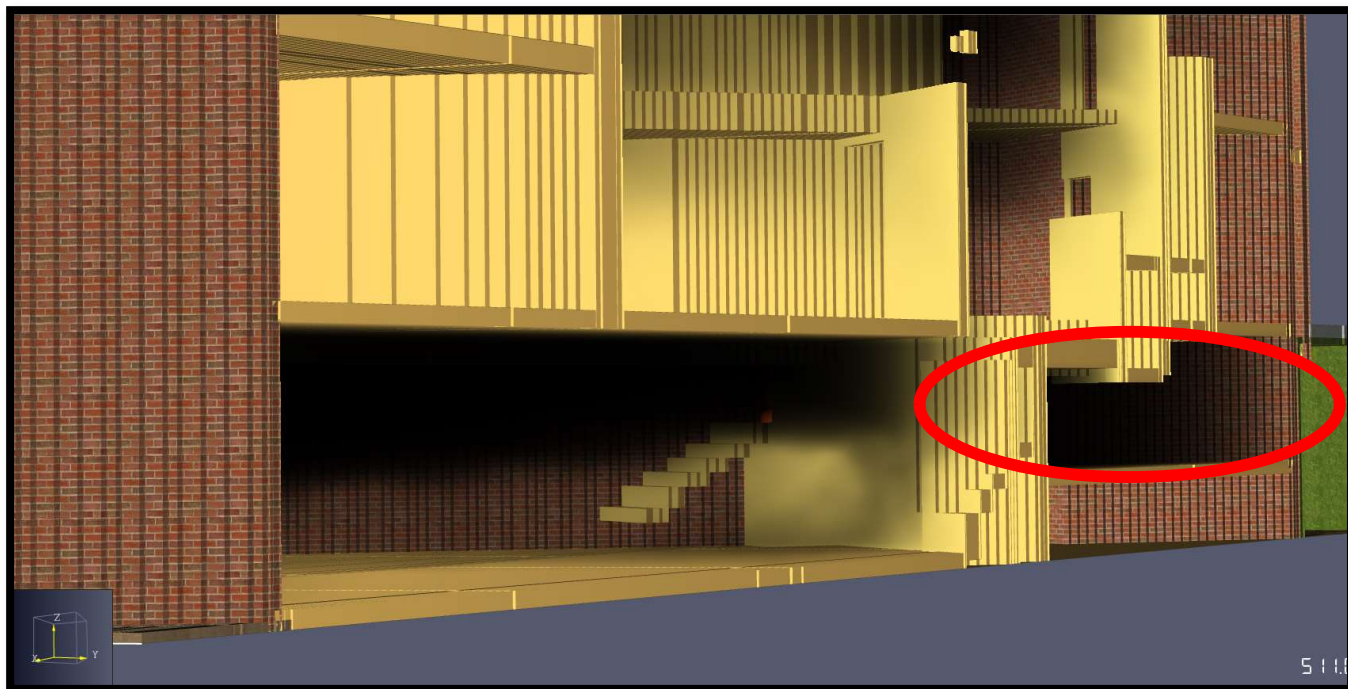
**Figure 50. Pyrosim Results image (sectional view) depicting the height of the crawl space relative to the basement. The crawl space is circled in red.**

Fires elevated in height within an enclosure (crawl space relative to basement floor height, fires located at ceiling level, or even stovetop fires) result in unique smoke filling characteristics in the larger enclosure. Frequently ventilation limited conditions occur prior to the smoke layer reaching the level of the floor. Once the smoke layer reaches the level of the flames, the fire size typically decreases (becomes ventilation limited) and the heat release rate (fire size) also decreases. This cyclic phenomenon is evident at this particular fire when the smoke layer descends below the level of the crawl space entrance, resulting in limited smoke filling below the crawl space entrance and “cold smoke” throughout the basement. Firefighters noted an elevated smoke layer that was inconsistent with a typical basement fire since both the fuel and the enclosure were elevated relative to the height of the rest of the basement.

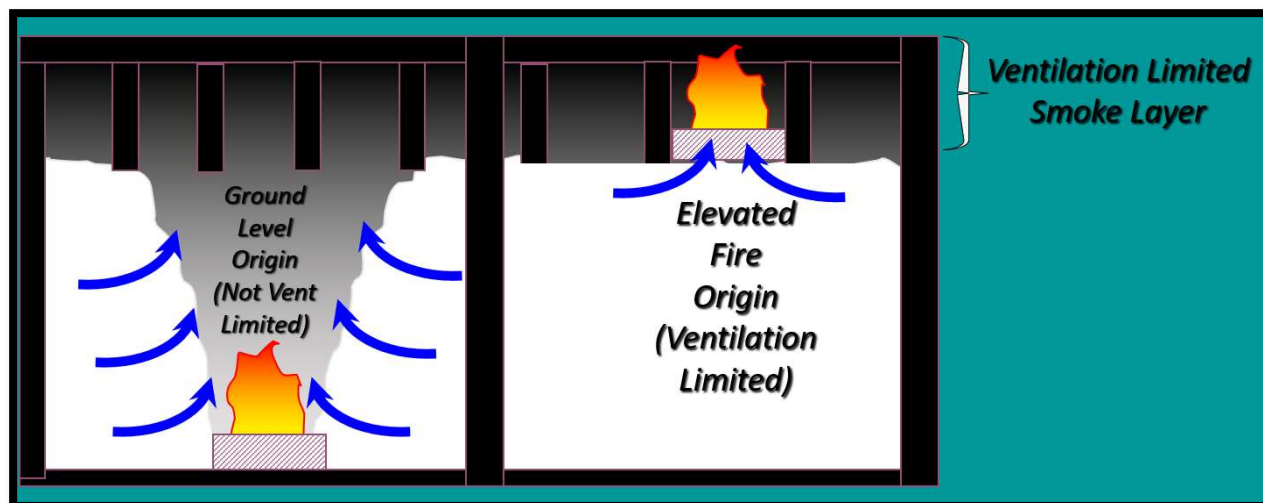
Figure 51. Image comparing the smoke layer development of an elevated fire versus a ground level fire. Fires elevated in height within an enclosure result in unique smoke filling characteristics relative to the larger enclosure. Frequently, ventilation limited conditions occur prior to the smoke layer reaching floor level. Since many CSST gas lines are routed through void spaces between the basement and the first floor, CSST basement fires can initially present as first floor fires, which results in firefighters operating over the seat of the fire and increasing risk of structural collapse.

The relatively complex fire dynamics associated with elevated fires are rarely taught to the fire service/fire investigation community. Firefighters should consider ensuring that the basement is completely free of smoke and fire, including at the basement ceiling level where CSST may be routed, as part of fire scene size-up operations.

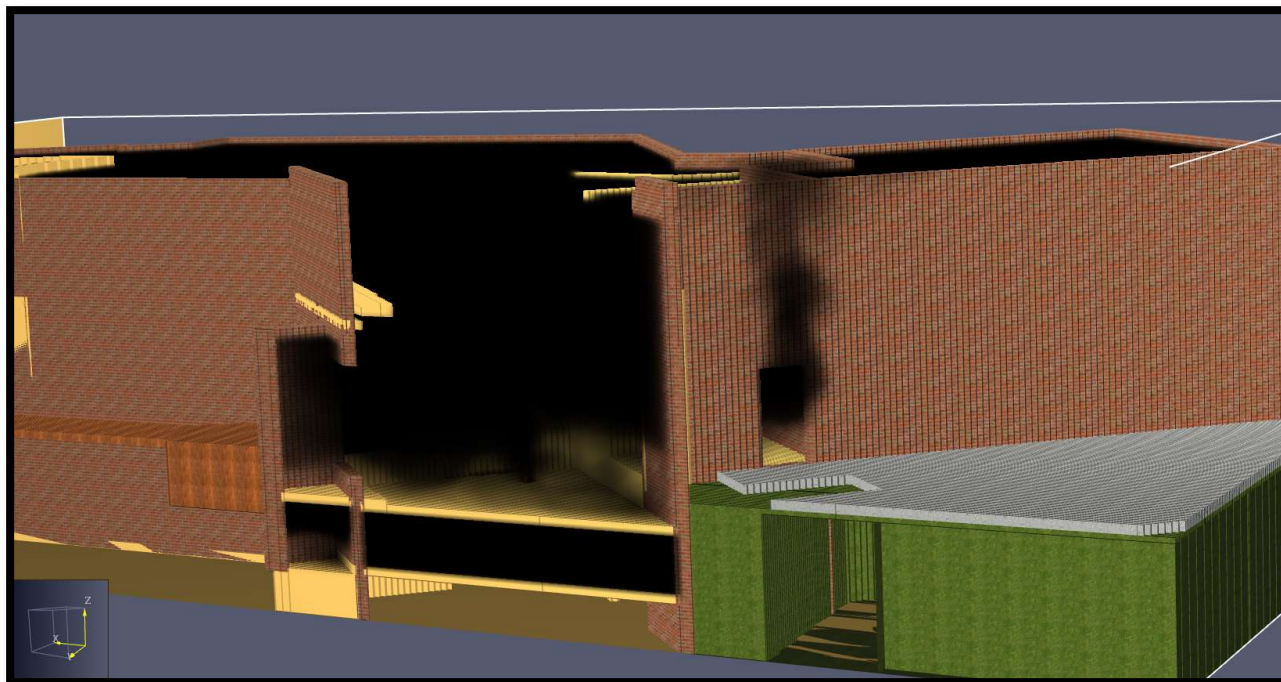
The mud room door remained open from the time of the initial 911 call throughout the entire incident. As the fire was located in the crawl space, this ventilation opening had minimal effect on initial fire growth as it was remote from the fire and functioned as both the inlet and outlet as the sole ventilation opening in the house. Noting smoke from the door (bi-directional flow) crews made initial entry through this opening, were unable to locate any flames and recognized indications of a possible basement fire below them and withdrew. Crews then made entry through a basement door located on the lower level of side C.

**Figure 55. The mud room door remained open throughout the incident. As the fire was located completely below the mud room, this ventilation opening had minimal effect on initial fire growth as it was remote from the fire. The opening functioned as both the inlet and outlet prior to the basement door opening.**

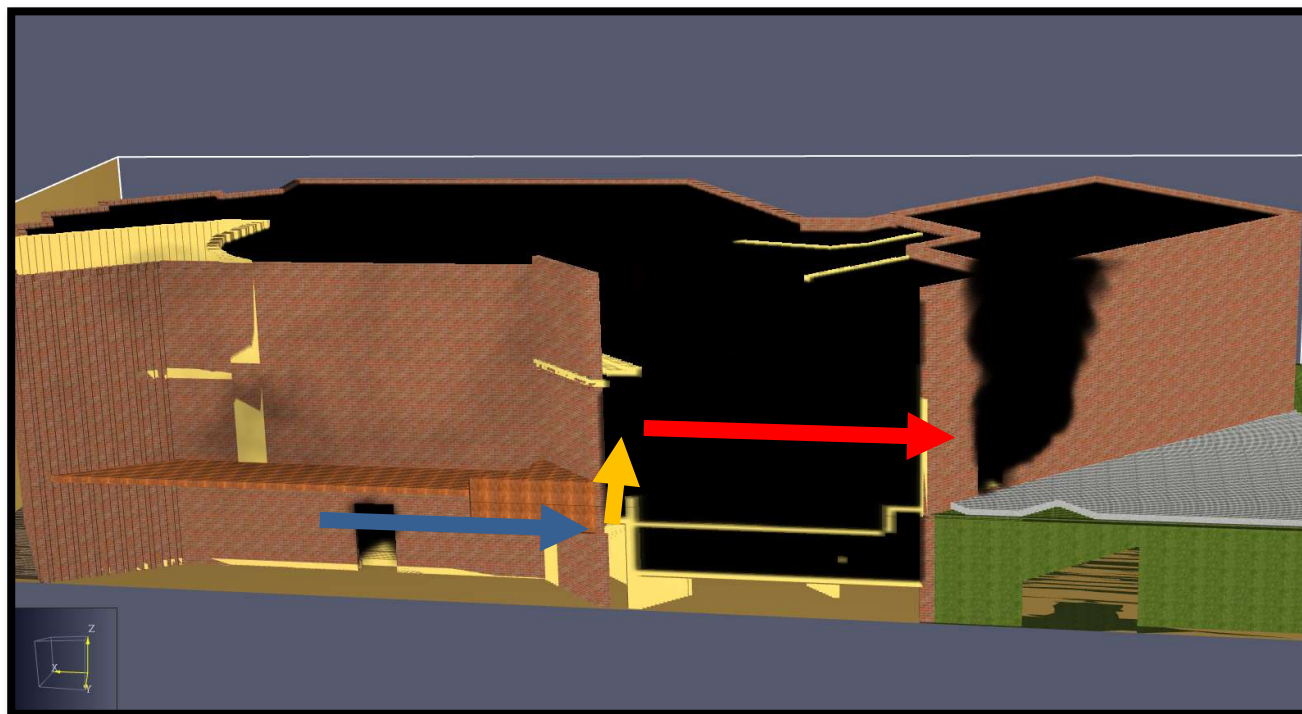
**Figure 56.** The basement door served as a unidirectional inlet, allowing fresh air to reach the fire in the crawl space and exhaust through the mud room door on the first floor. This buoyancy driven gas flow was a function of the height difference between the two openings.

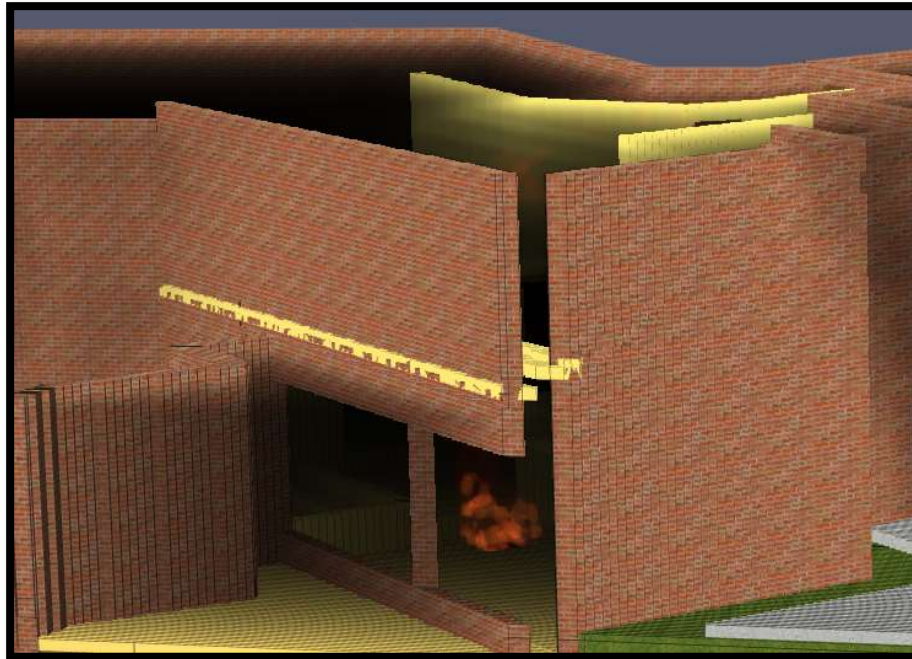
**Figure 57.** This rapid increase in fresh air along the inlet, to the seat of the fire, allowed flames to become visible through an exterior window on the first floor. Once the basement door was again shut as crews repositioned, the fire once again became ventilation limited and the flames were no longer visible from the exterior. Firefighter Flynn fell through the hole and into the burning crawl space when he attempted to locate the previously seen flames on the first floor.

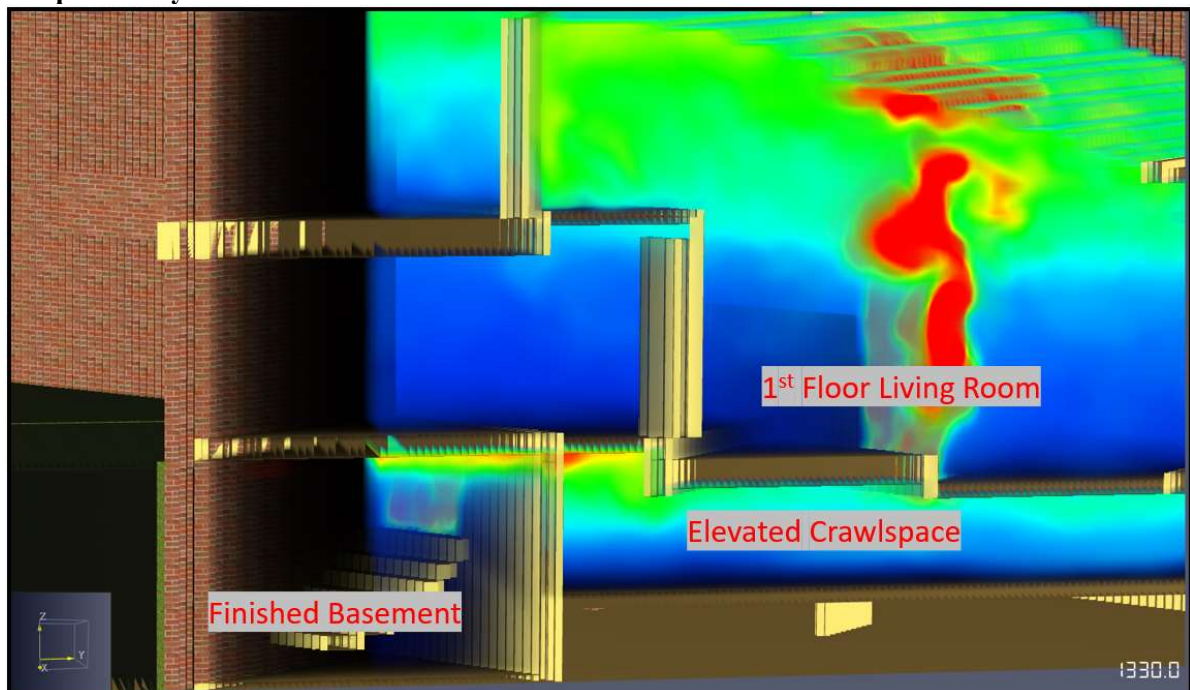
**Figure 58.** Pyrosim Results image depicting high heat conditions through the crawl space, venting to the first floor. The heat energy traveled along the flow path and eventually exhausted through the mud room door.

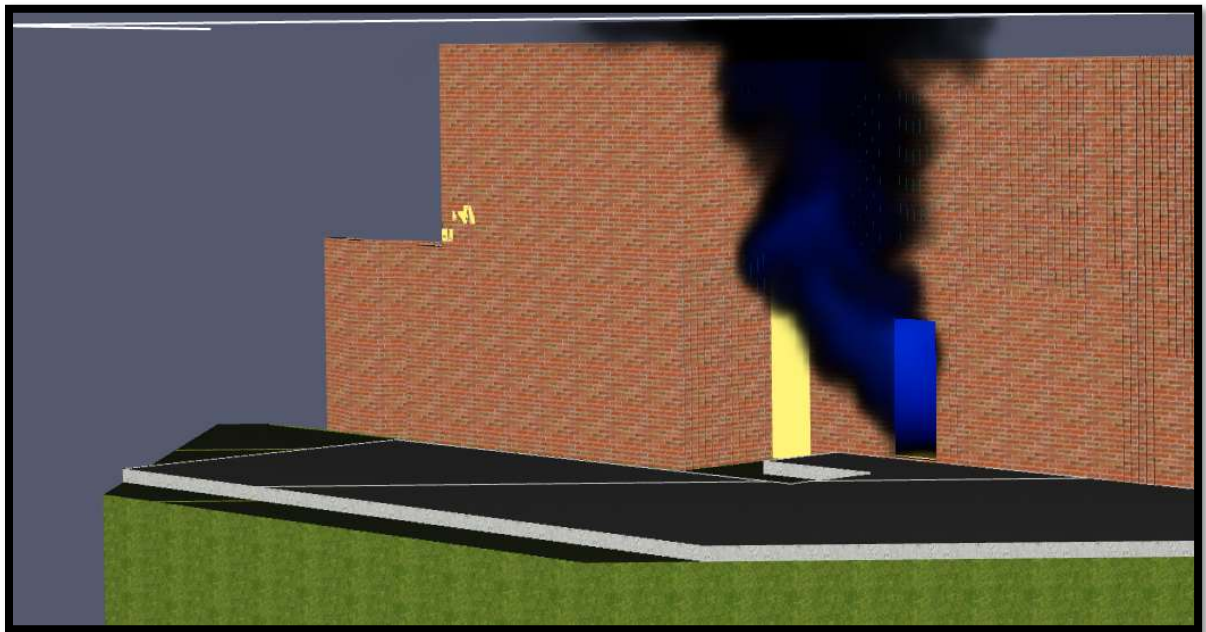
**Figure 59. Pyrosim Results image depicting unidirectional flow path through the mud room door at the time of the MAYDAY/RIT rescue operation.**

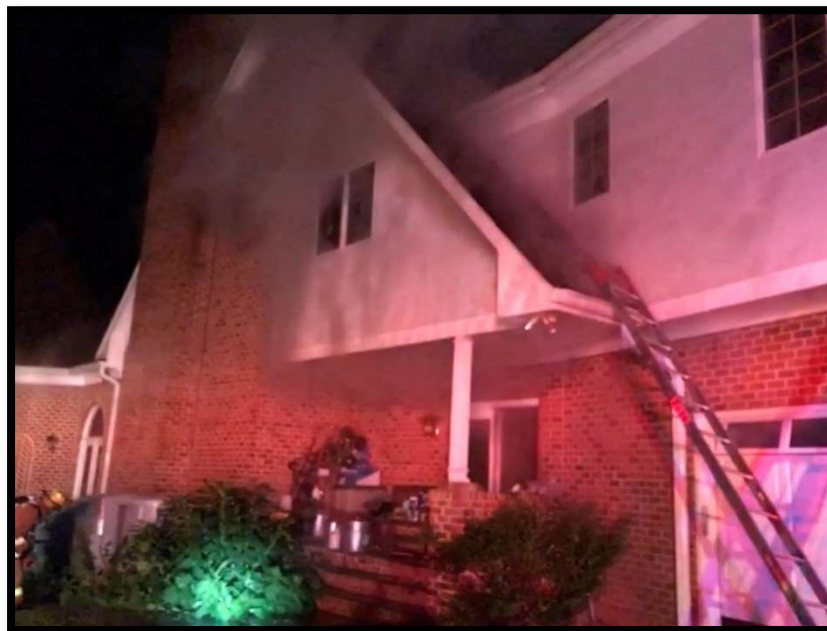
**Figure 60. Photograph of upper level side C (first floor) mud room entrance door captured immediately prior to Firefighter Flynn entering with a charged hoseline after firefighters noticed flames on the first floor from the exterior. Note light smoke and the bi-directional flow out of the mud-room door as the basement door (inlet) was closed at this time. Firefighter Flynn falls into the burning crawl space approximately 2 minutes after this photograph was taken.**

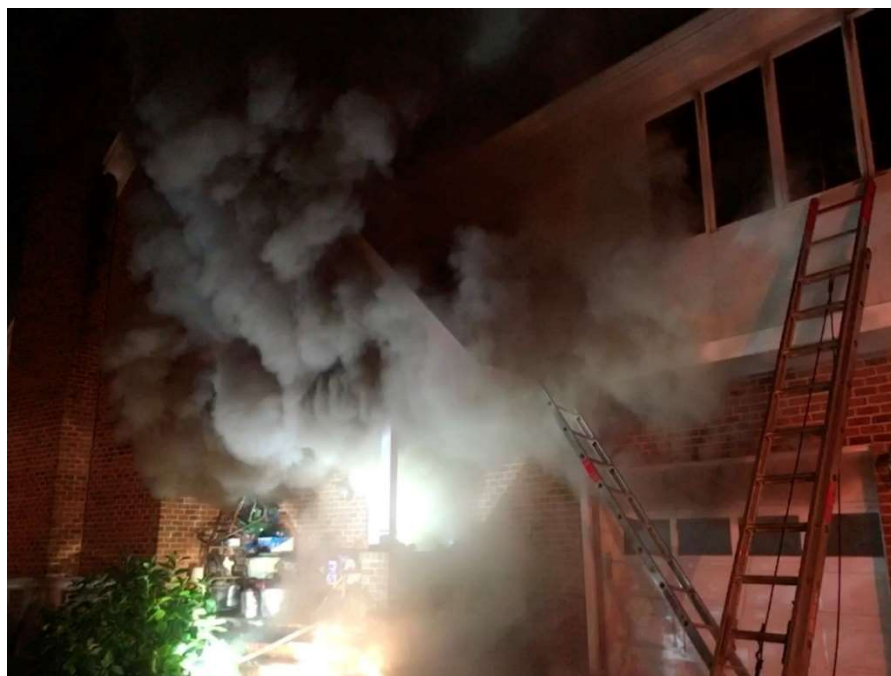
**Figure 61. Photo of the same mud room entrance door captured AFTER Firefighter Flynn entered and falls through the hole into the crawl space. Note the hoseline on the stairs to the first floor landing. This photo was taken during the RIT rescue operation. Note the transition to a unidirectional outlet with dense, high-velocity smoke exhausting from floor to ceiling. The first floor was untenable for firefighters at this point.**

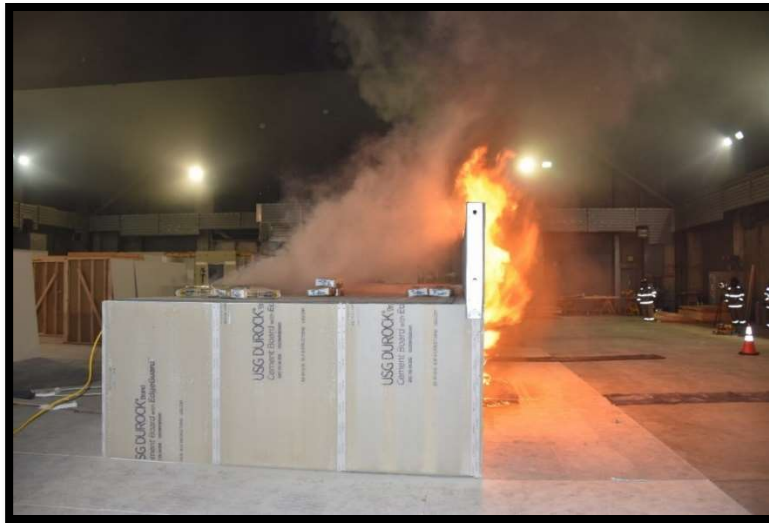
While the floor joists and OSB sheathing supported flame spread and burned-away, the non-combustible tile and tile backing appeared relatively cool on infrared thermal imaging cameras and remained intact despite having compromised structural support below. The relatively massive construction of the flooring system masked the heat signatures one might expect from a fully-involved crawl space fire and a structurally-compromised flooring system below.

**Figure 62. Smoke production through the tile floor with a well-developed fire in the crawl space underneath. The thermally thick (massive) living room floor construction helped mask the well-developed fire underneath firefighting crews operating above.**

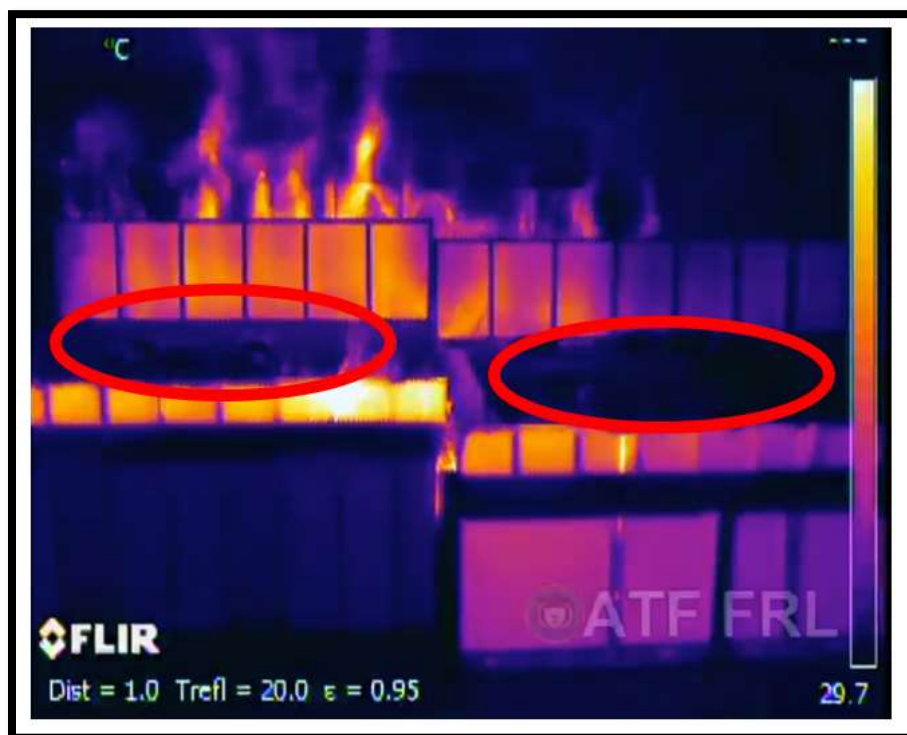
**Figure 63. Despite having a fully-involved crawl space and compromised structural integrity, the top of the flooring tiles appeared relatively cool on thermal imaging IR cameras (areas circled in red).**

The collapse risk is compounded by the fact CSST fires can remain concealed in the structural void space above the basement and flames often vent at the first floor level (and not in the basement), causing firefighters to operate over the seat of the fire. There are no reliable indicators of pending structural collapse for firefighters and Firefighter Flynn was unaware of the fire in the crawl space below him.<sup>8</sup> When a lightning strike is suspected, firefighters should gain access and rule-out fire spread in concealed spaces containing combustible structural members on all levels of the structure. Special attention should be paid to the flooring system between the basement and first floor as collapse into the basement is possible if a fire originated in this area.

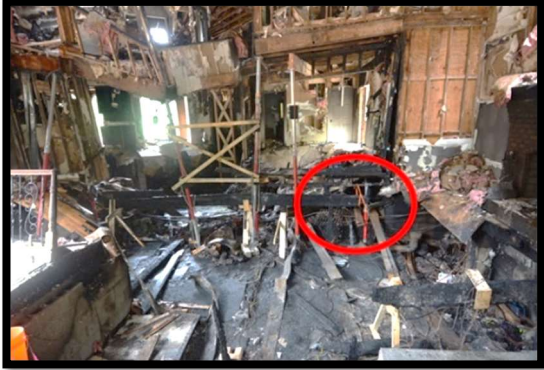
<p><b>MAYDAY Location</b></p>	<p>While attempting to suppress the 1st floor fire, MAYDAY firefighter falls through 1st floor into burning crawl space below. Firefighter immediately calls MAYDAY. Multiple layers of thick tile/cement board at hole location. CSST flame consumed combustible structural members below the hole location.</p>

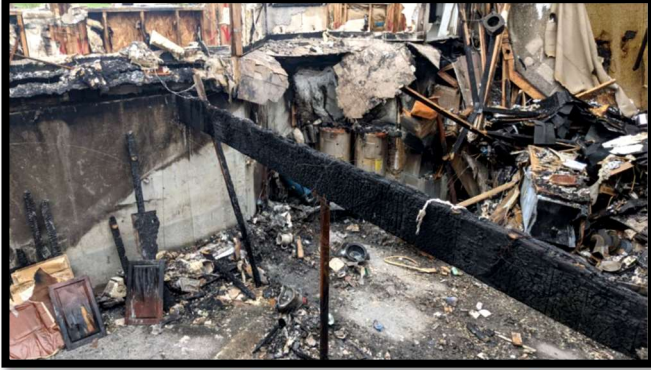
<p>While attempting to suppress the 1st floor fire, MAYDAY firefighter falls through 1st floor into the burning basement below. Firefighter immediately calls MAYDAY. Multiple layers of thick tile/cement board at hole location. CSST flame consumed combustible structural members below hole location.</p>
